Inspecting dock road slab structures with ground penetrating radar

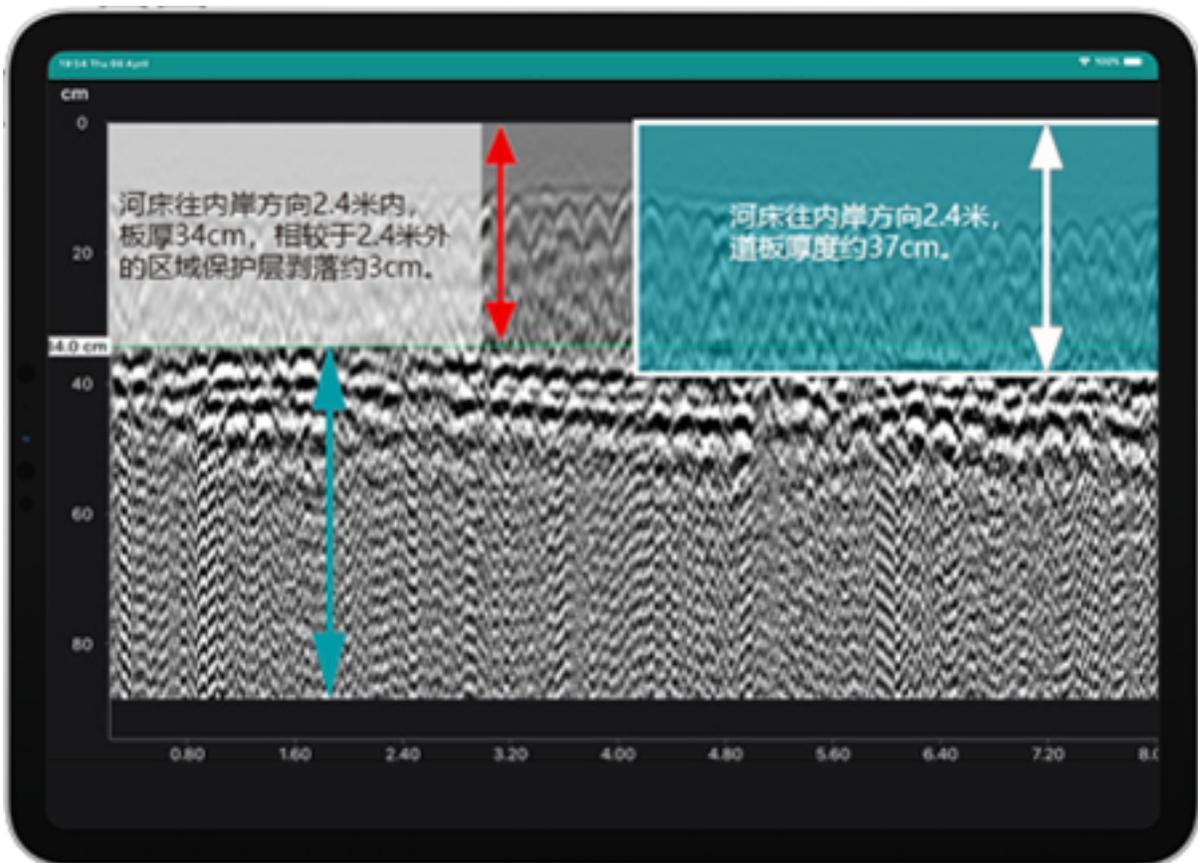
Suspected damage to the road plate detected by GP8000

Through the GP8000 radar checking test, it is not difficult to find that the thickness of front plate where riverbed is within 2.4 meters to the inner bank is about 34cm; and the thickness of back plate where the riverbed is 2.4 meters away from the inner bank is about 37cm. that means the protective layer of the front plate is reduced by about 3 cm.

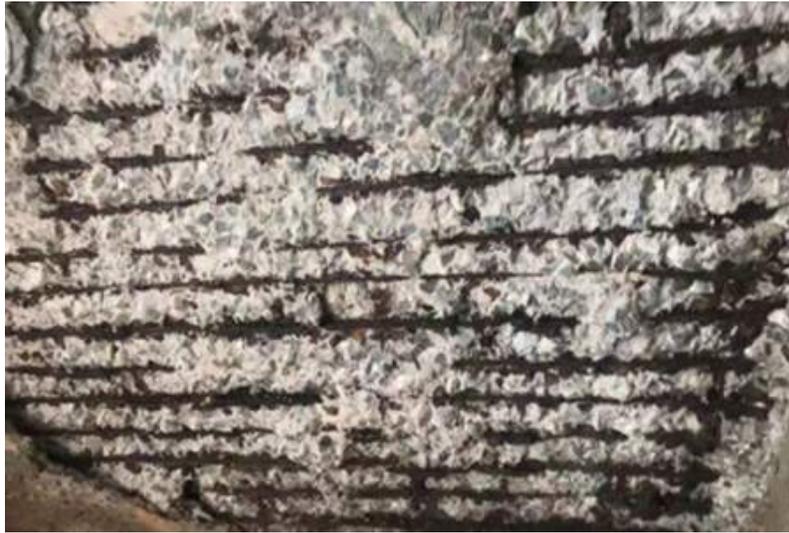
Rusting and peeling areas (front plate)

During the dry period, the field conditions verified by the inspectors coincided with the response of the [GP8000](#) GPR detection signal. Due to the impact of the water wave, the front road plate is attacked by moisture and ions for a long time, resulting in the long-term corrosion activation state of the steel reinforcement inside the concrete. This caused the concrete protective layer to corrode and crack, peeling, resulting in the exposed steel bar, which in turn aggravates the damage of the steel bar and the lack of bearing capacity of the road plate.

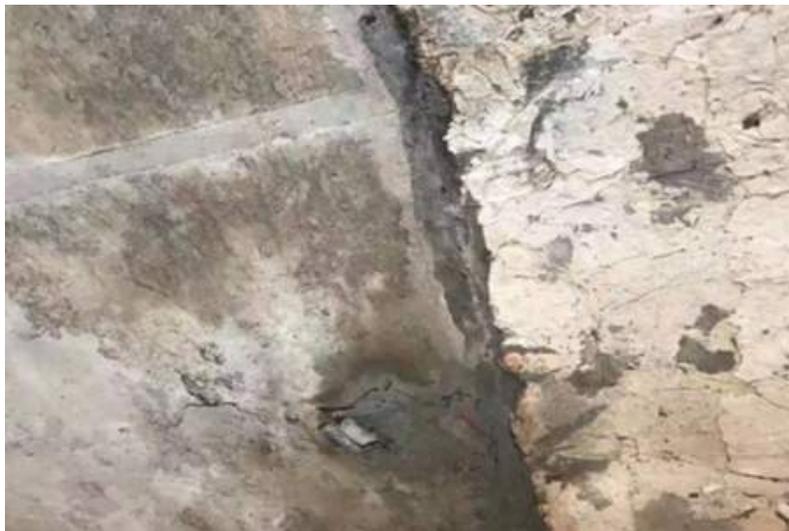
Undamaged areas (back plate)

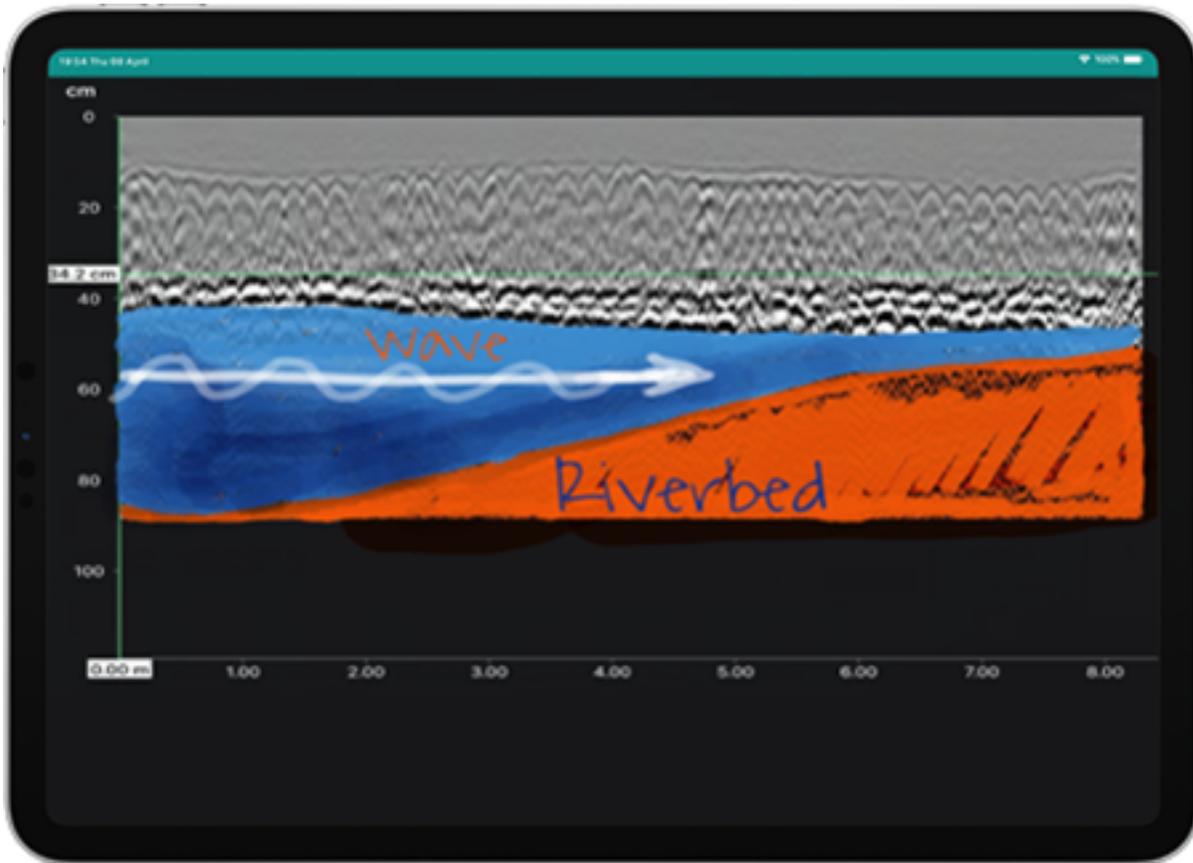
Cross-sectional view of water wave erosion
