# Inspecting dock road slab structures with ground penetrating radar

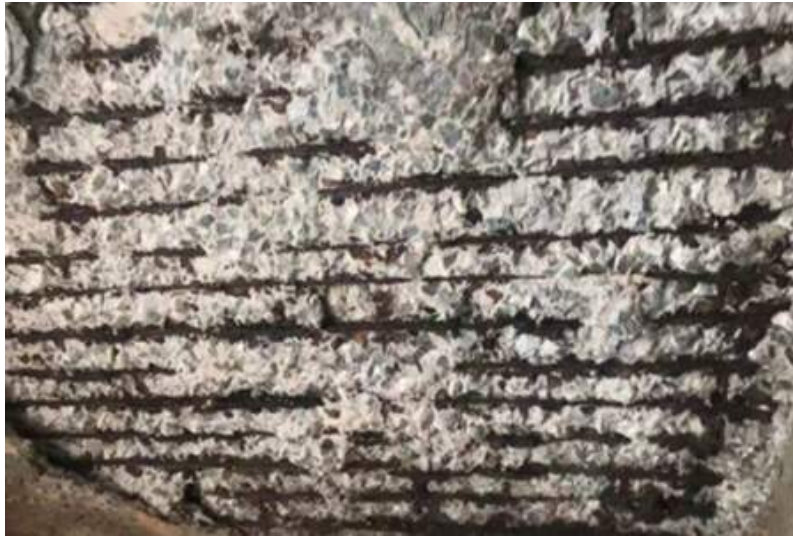
Rusting and peeling areas (front plate)

During the dry period, the field conditions verified by the inspectors coincided with the response of the [GP8000](#) GPR detection signal. Due to the impact of the water wave, the front road plate is attacked by moisture and ions for a long time, resulting in the long-term corrosion activation state of the steel reinforcement inside the concrete. This caused the concrete protective layer to corrode and crack, peeling, resulting in the exposed steel bar, which in turn aggravates the damage of the steel bar and the lack of bearing capacity of the road plate.
