# Inspecting dock road slab structures with ground penetrating radar

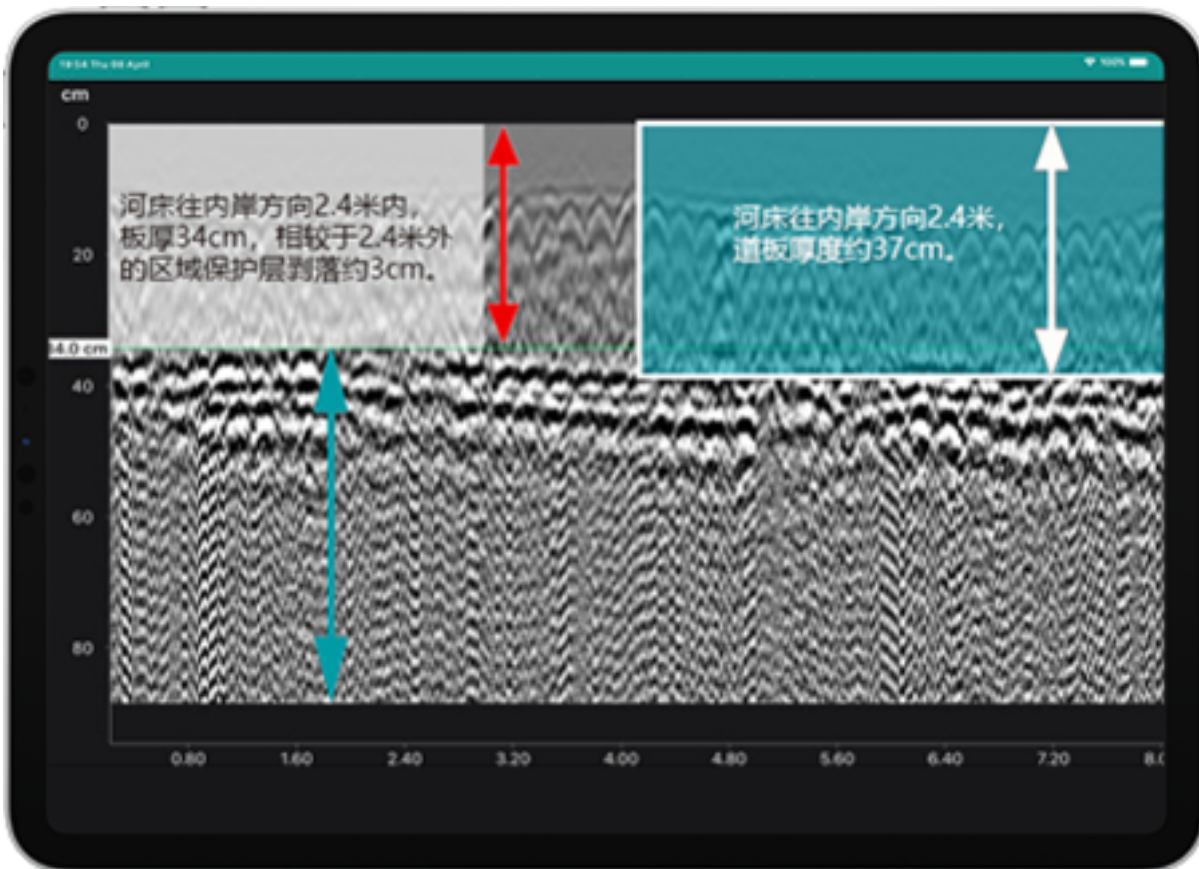
Suspected damage to the road plate detected by GP8000

Through the GP8000 radar checking test, it is not difficult to find that the thickness of front plate where riverbed is within 2.4 meters to the inner bank is about 34cm; and the thickness of back plate where the riverbed is 2.4 meters away from the inner bank is about 37cm. that means the protective layer of the front plate is reduced by about 3 cm.
