# Detecting Cavities in a Tubular Bridge with Prestressing Channels

To perform a structural re-assessment for the modification of a tubular bridge from the 1980s, with a span of 150 m, it was necessary to map the state of the prestressing. The prestressing system consists of channels with riveted prestressing steel (strands), which are subsequently filled with injection grout.

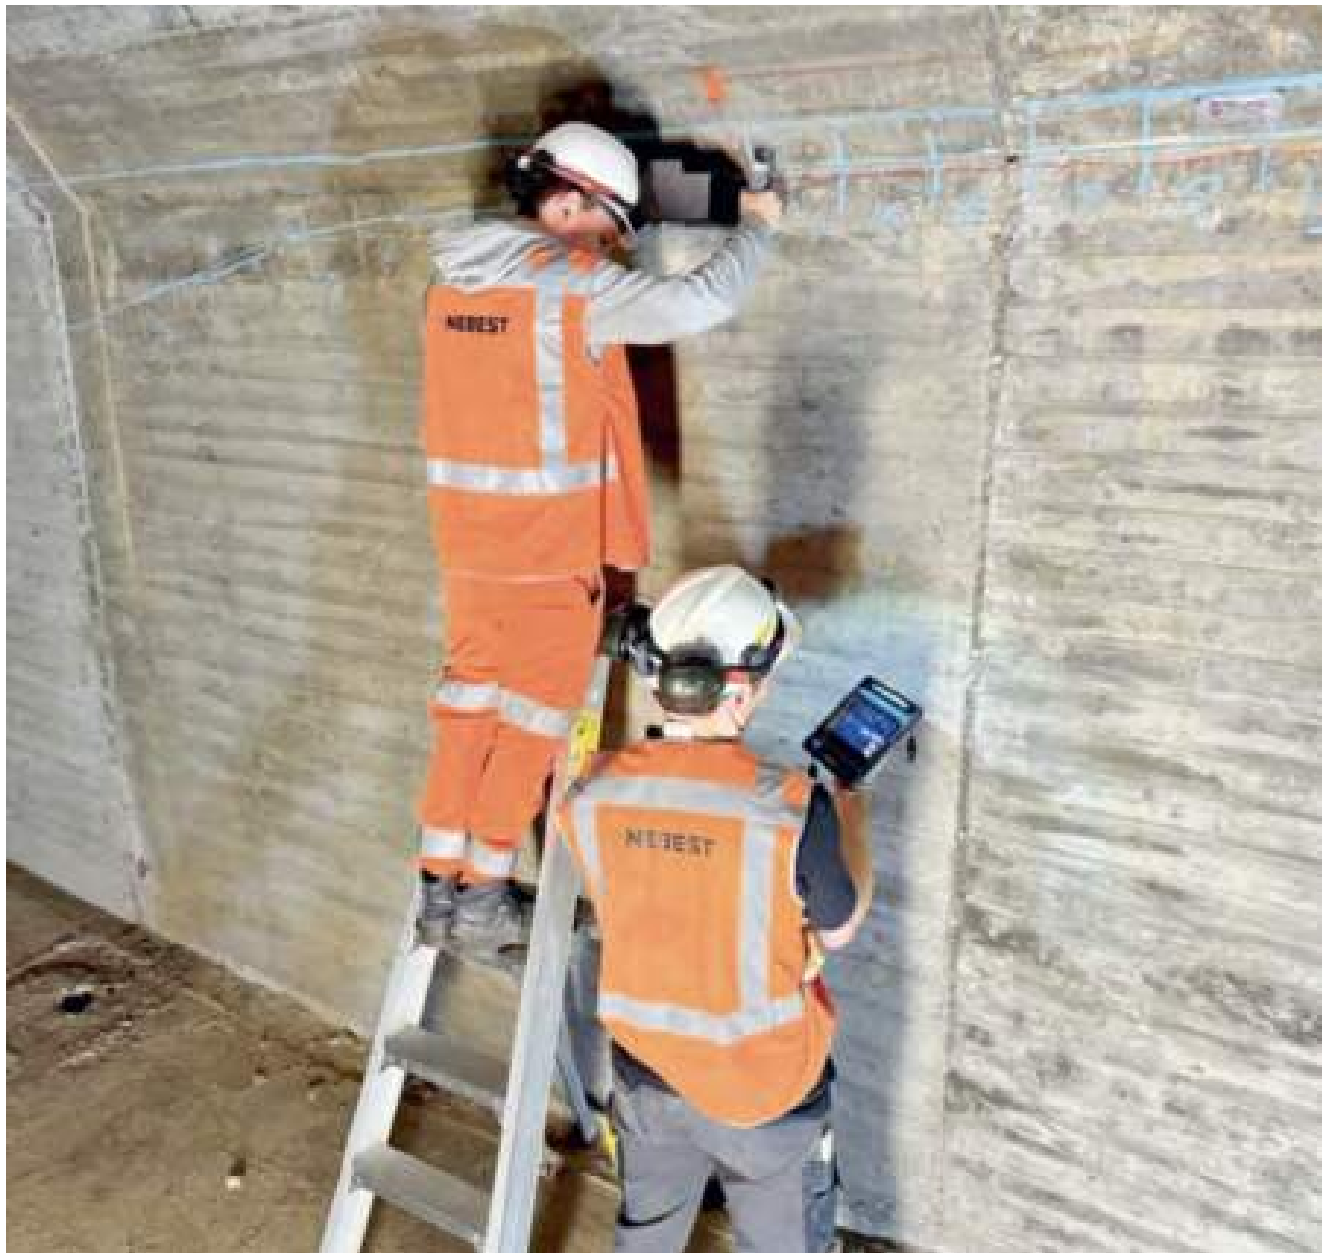
The engineer pressed the ultrasonic device against the concrete surface along the length of the prestressing channel at a fixed intermediate position repeatedly. Then all individual measuring points are software automatically put together to form a line scan.

Nebest team using the PD8050 ultrasonic imaging system to detect cavities
