Bolt inspection: Internal Defect Assessment & Data Management

This application note describes how to assess bolts on linear assets such as railway tracks.

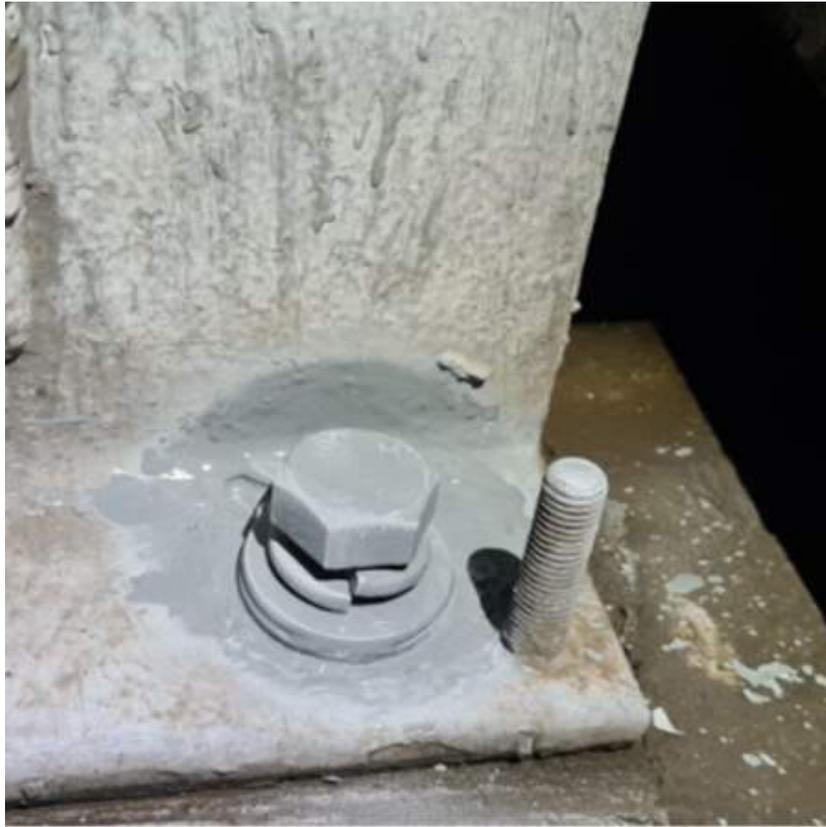
Bolt in-situ.

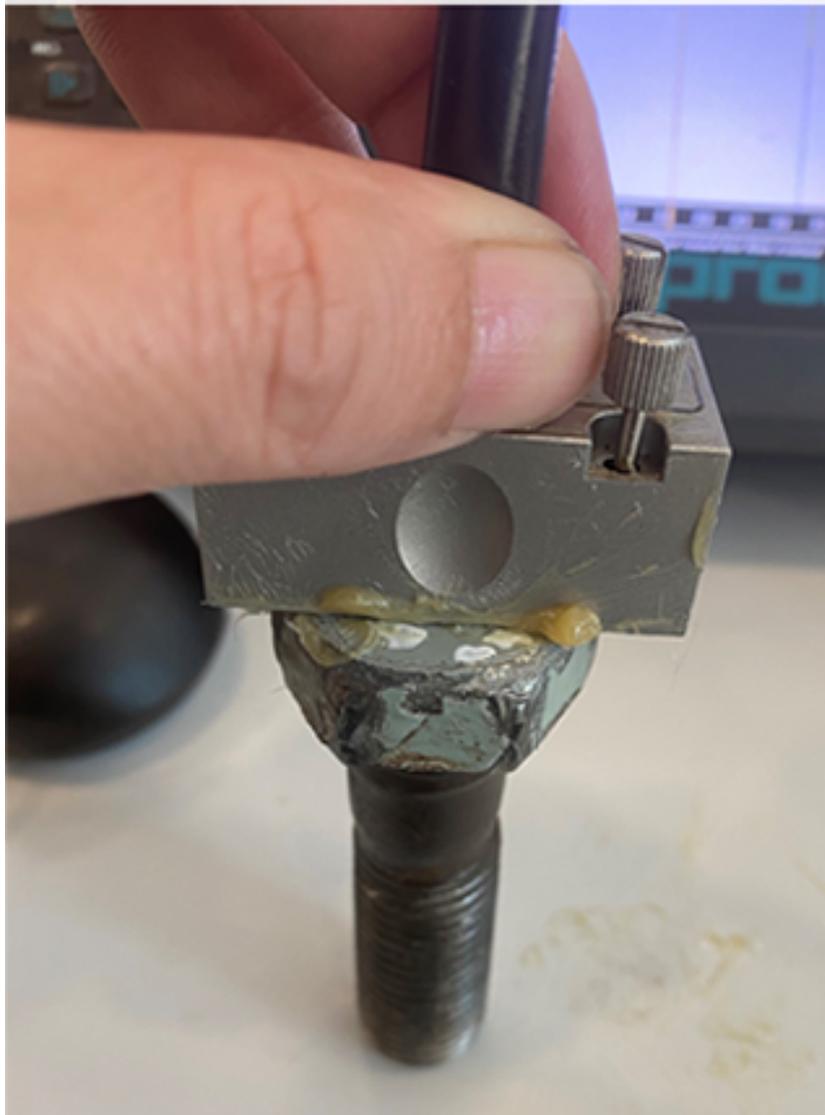
Phased array probe being held on a bolt. The bolt is ex-situ for the 'proof of concept' project but an identical testing method can be used with the bolt in-situ

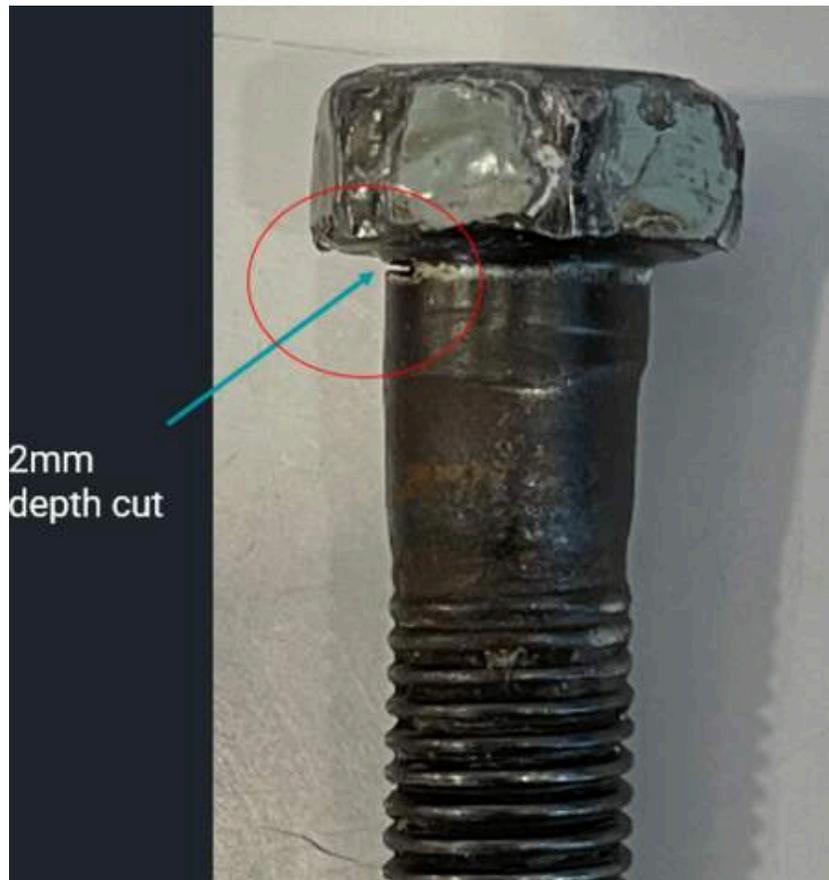
Bolt with a 2mm depth cut to simulate a defect.

To test out the proposed solution, a defect was simulated using a 2 mm cut, just beneath the bolt head. Phased array testing was used to get images from the two bolts - one with no cuts and one with the 2mm cut. In the images, the bolt threads and base of the bolt can be identified. And in the bolt with the 2mm cut, an additional indication is visible from the 2mm cut. Further tests were conducted and it was concluded that ultrasonic array technology is a suitable approach for testing and sentencing bolts on-site.

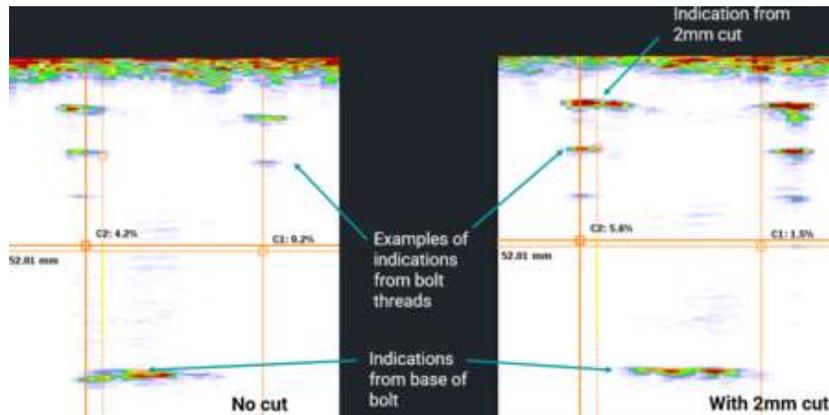
Phased array images from a bolt with no cut (left hand side) and a bolt with a 2mm cut (right hand side)
