## Bolt inspection: Internal Defect Assessment & Data Management

This application note describes how to assess bolts on linear assets such as railway tracks.

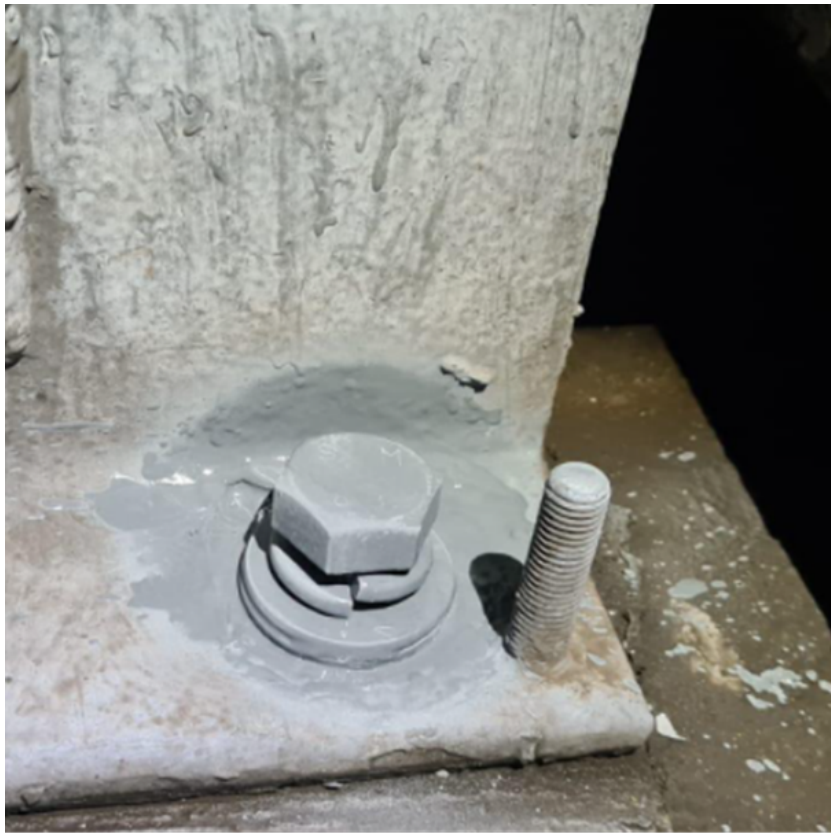
Bolt in-situ.

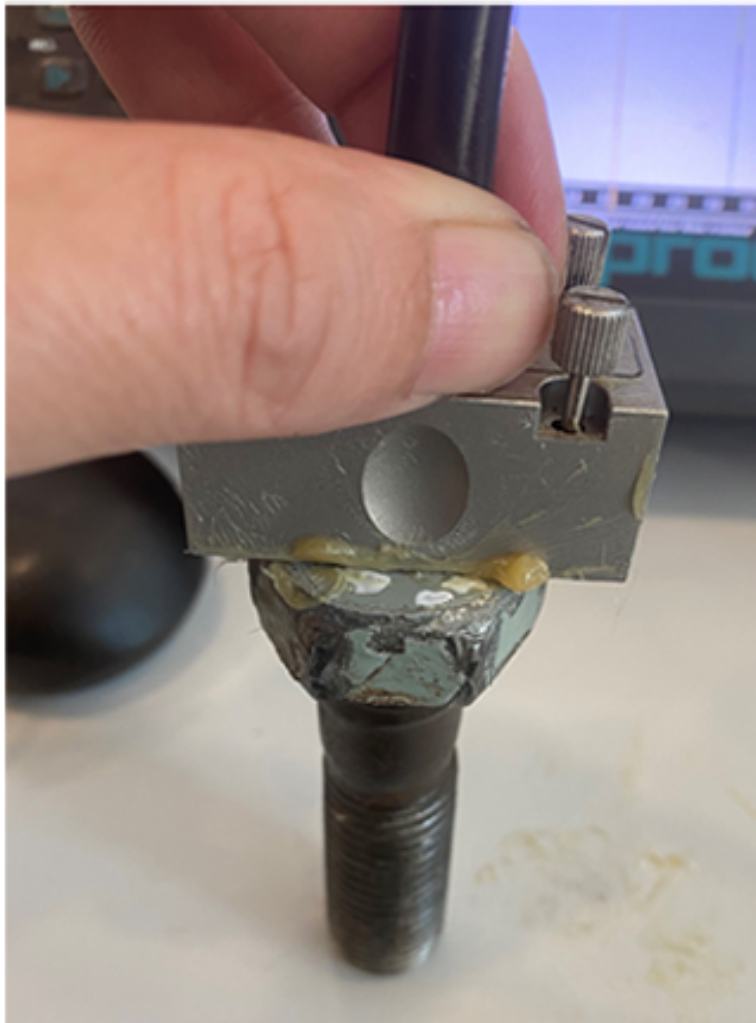
Phased array probe being held on a bolt. The bolt is ex-situ for the 'proof of concept' project but an identical testing method can be used with the bolt in-situ

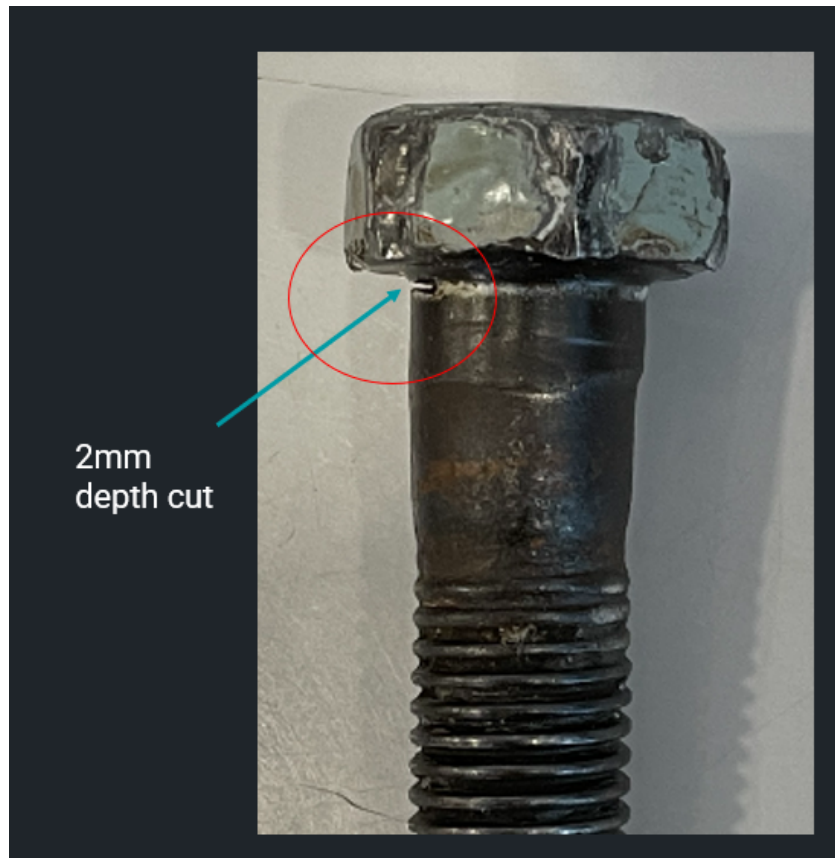
Bolt with a 2mm depth cut to simulate a defect.

To test out the proposed solution, a defect was simulated using a 2 mm cut, just beneath the bolt head. Phased array testing was used to get images from the two bolts - one with no cuts and one with the 2mm cut. In the images, the bolt threads and base of the bolt can be identified. And in the bolt with the 2mm cut, an additional indication is visible from the 2mm cut. Further tests were conducted and it was concluded that ultrasonic array technology is a suitable approach for testing and sentencing bolts on-site.
