## Bolt inspection: Internal Defect Assessment & Data Management

This application note describes how to assess bolts on linear assets such as railway tracks.

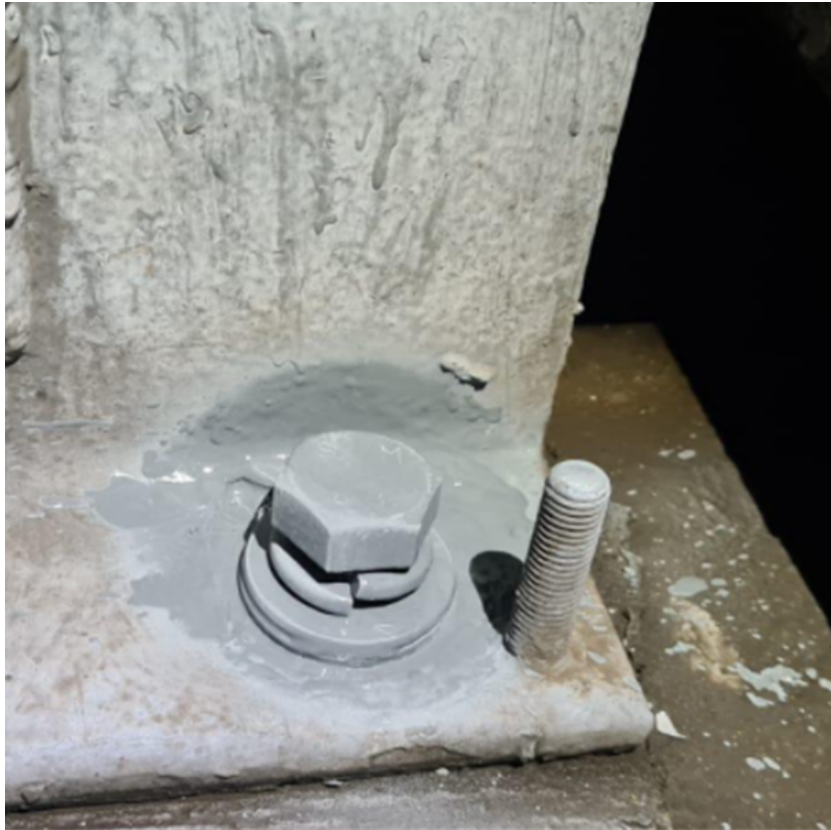
Bolt in-situ.

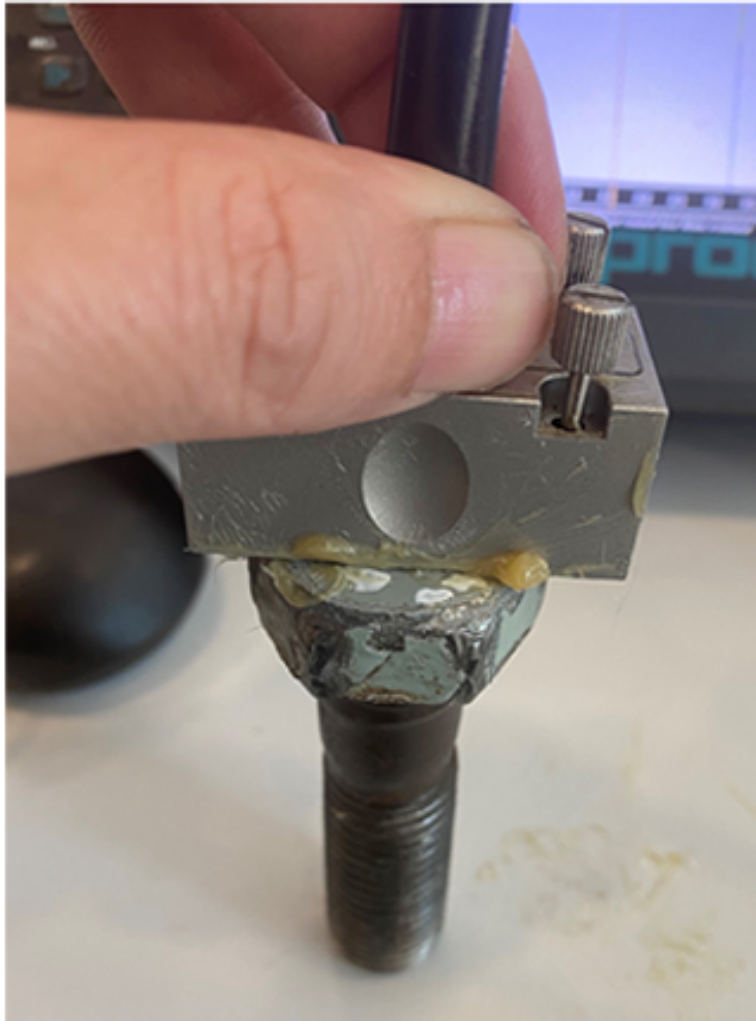
Phased array probe being held on a bolt. The bolt is ex-situ for the 'proof of concept' project but an identical testing method can be used with the bolt in-situ

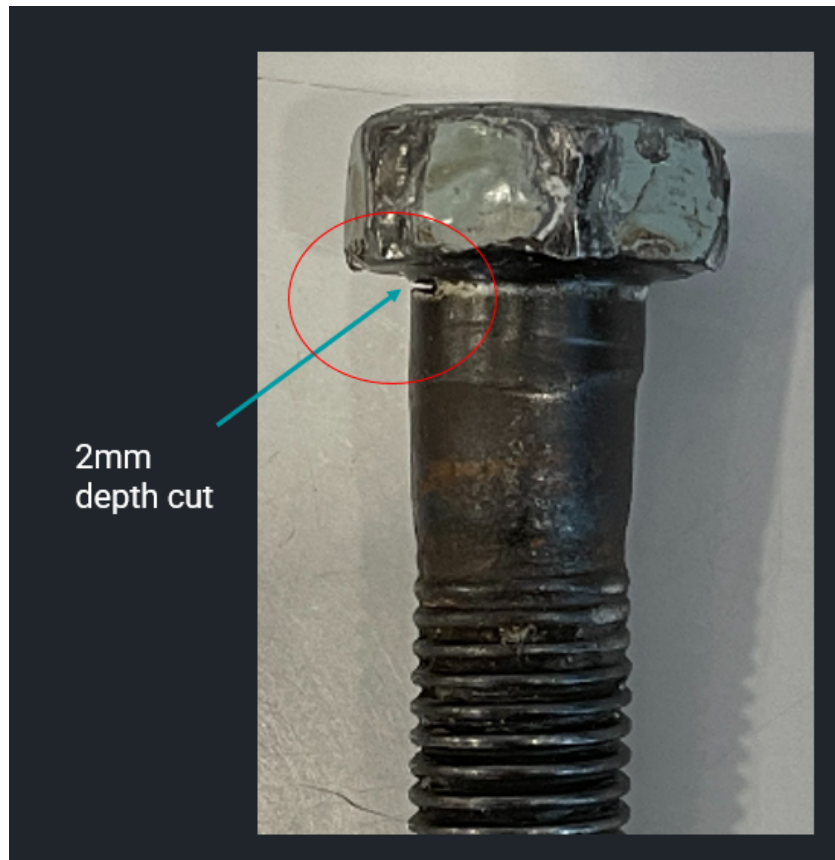
Bolt with a 2mm depth cut to simulate a defect.

To test out the proposed solution, a defect was simulated using a 2 mm cut, just beneath the bolt head. Phased array testing was used to get images from the two bolts - one with no cuts and one with the 2mm cut. In the images, the bolt threads and base of the bolt can be identified. And in the bolt with the 2mm cut, an additional indication is visible from the 2mm cut. Further tests were conducted and it was concluded that ultrasonic array technology is a suitable approach for testing and sentencing bolts on-site.

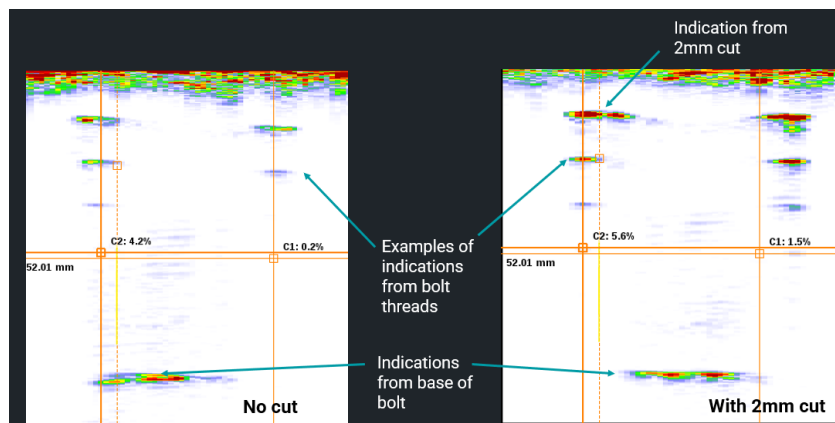
Phased array images from a bolt with no cut (left hand side) and a bolt with a 2mm cut (right hand side)
