Efficiently Monitoring the Performance of Road Markings and Signs

Overview

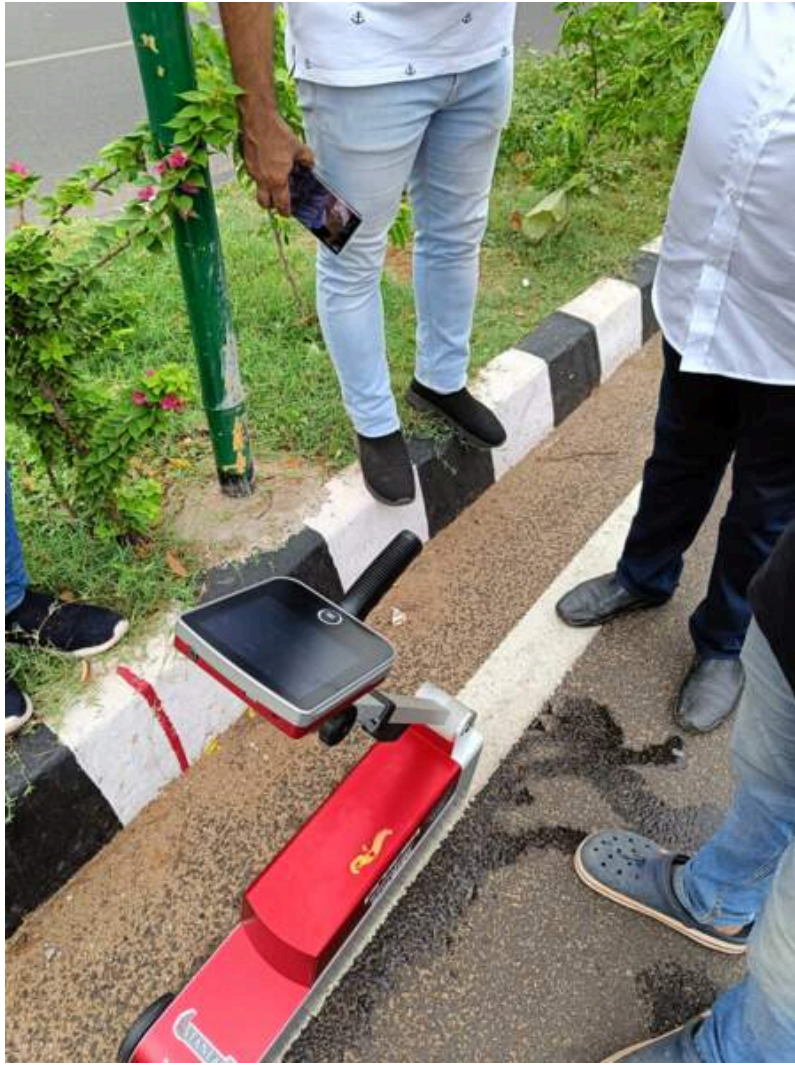
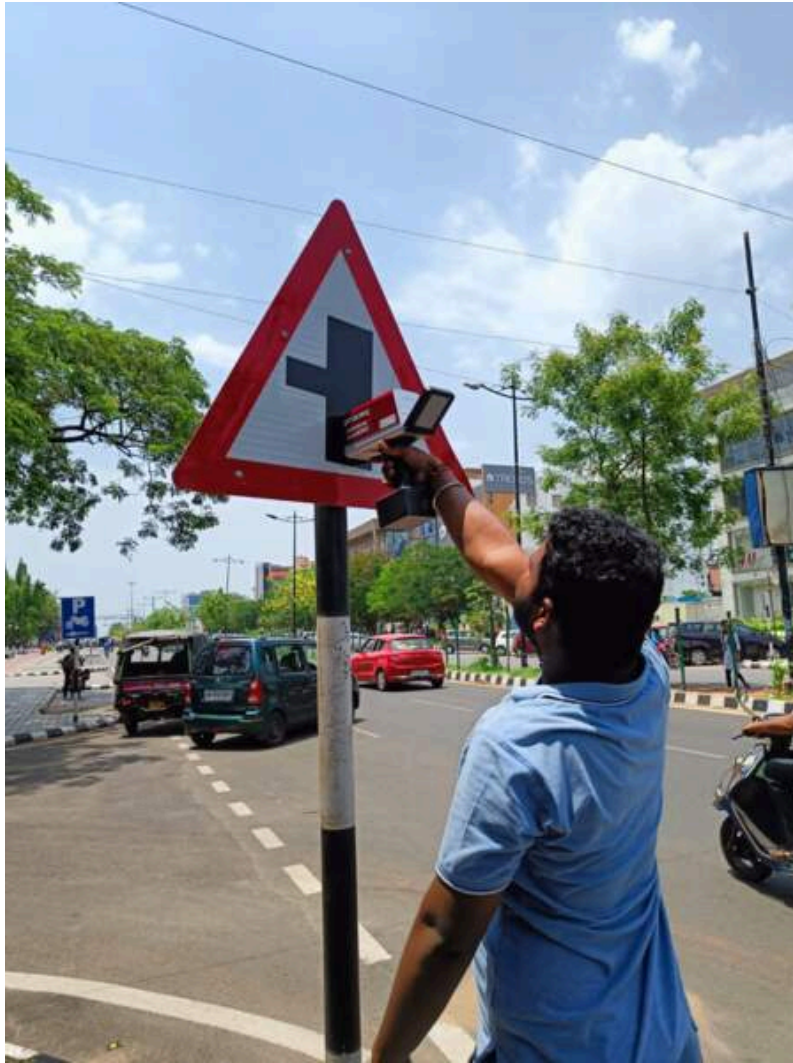
1. The advanced ZRM6014RL Retroreflectometer was used for pavement markings with GPS.
2. Zehntner ZRS6060 Retroreflectometer was used for road signages with GPS.

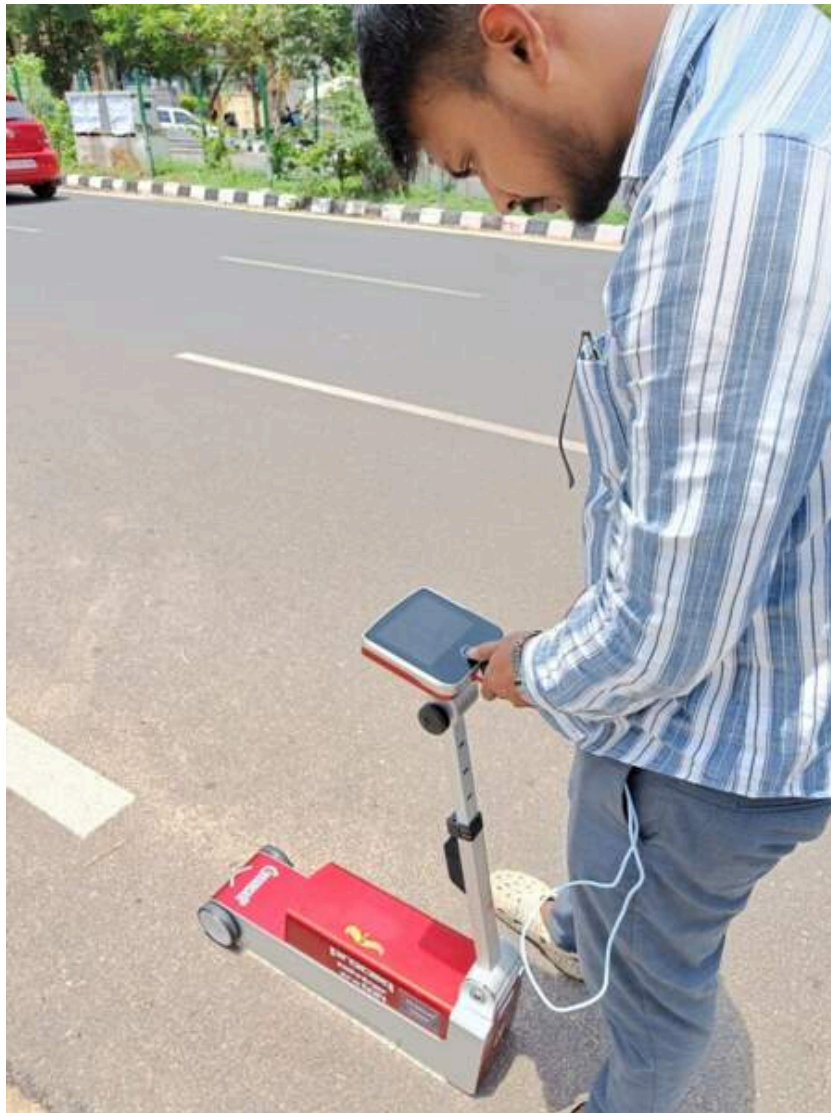
Measuring example ZRM 6014 with optional camera

Clever "MappingTools" software for easy data display and analysis

The screenshot displays the MappingTools software interface. At the top, there is a satellite map of an urban area with a red location pin and a red box labeled "Geographical position of the measurement". Below the map is a data table with columns for "Date", "Time", "Value", "Unit", "Status", and "Location". A red box labeled "Measuring value" points to a row in the table. To the right of the table is a camera view of the measuring area, with a red box labeled "Picture of the measuring area" pointing to it. The camera view shows a road surface with a white line and a red box labeled "Measuring value" pointing to a specific spot on the road.

Enabled with 5.7" high-resolution color touchscreen, the retroreflectometer offers excellent visibility under all light conditions. The retroreflectometer logs all measurements with precise geolocation & provides comprehensive reports quickly with the help of user-friendly reporting software at ease.
